Sample 656-061324

Emergency Runtz

Sample Submitted: 06-13-2024; Report Date: 06-20-2024

Plant Material: Hemp Flower

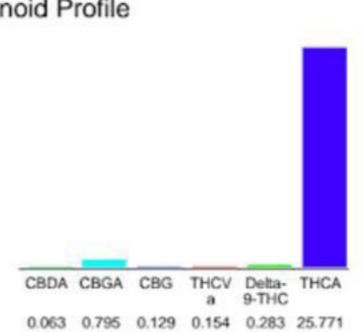
Cannabinoid Profile

Cannabinoid	% wt	mg/g
CBDA	0.063	0.63
CBGA	0.795	7.95
CBG	0.129	1.29
THCVa	0.154	1.54
Delta-9-THC	0.283	2.83
THCA	25.77	257.71
Total Cannabinoids	27.20	272.0
Calculated Total THC	22.88	228.84
Calculated CBD Yield	0.06	0.55

Calculated Total THC = Delta-9-THC + 0.877 * THCA Calculated Maximum CBD Yield = CBD + 0.877 * CBDA
